October 2020

# Sulzer White Paper

# Addressing stress corrosion cracking in the turbomachinery industry

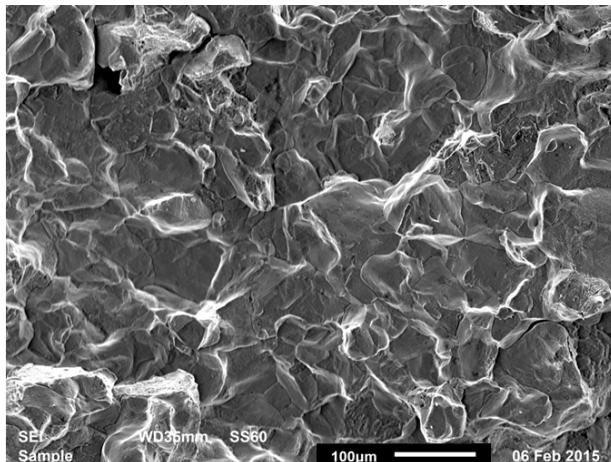
Figure 1: SEM image of a fracture surface showing intergranular fracture due to stress corrosion cracking.

Figure 1 shows an SEM image of a fracture surface exhibiting intergranular mode of propagation on an integral disk of a steam turbine rotor.

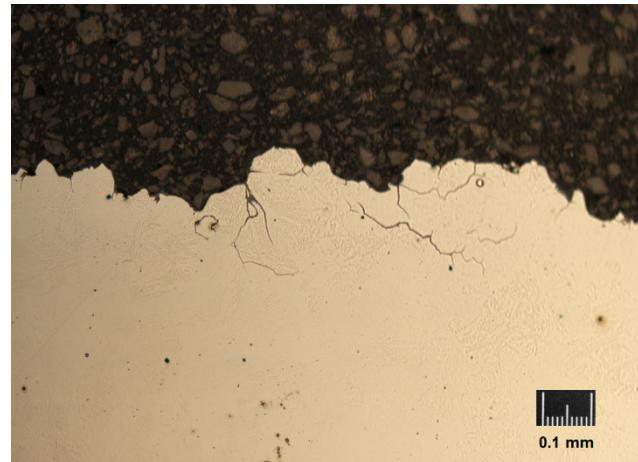
Figure 2: As-polished cross section through a fracture surface showing branched cracking due to stress corrosion cracking.

Branching of a crack is another common characteristic of SCC and optical metallography through a fracture/crack will help identify this feature. Both modes of propagation can exhibit crack branching. An example of branched intergranular cracking is shown in figure 2. Similarly, optical metallography through a fracture surface may also show branching of transgranular cracks.

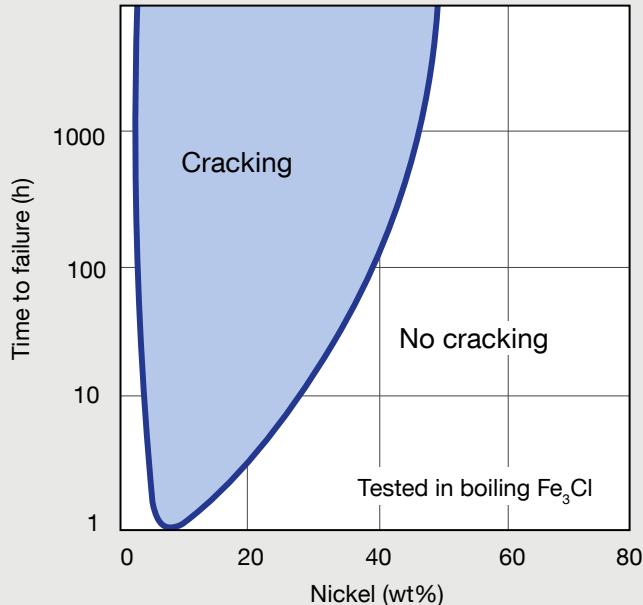
Figure 3: A sample Copson curve [1] showing susceptibility of stress corrosion cracking in alloys with different amounts of nickel.

This is important since certain chemicals are known to cause SCC in particular alloys. For example, nitrates are known to cause SCC in low carbon steels, but not in austenitic stainless steel. The chemical composition of the base metal can be checked to confirm its susceptibility to SCC. An energy dispersive spectroscopy (EDS) on the fracture surface helps identify the corrosive agents. The investigation can also include a full chemical analysis of the working fluid going through the machine. Lastly, a Copson curve can be used if a change of material is considered or to evaluate if the original base metal was a good choice for the application. For example, the Copson curve in figure 3 relates the stress corrosion susceptibility to the nickel content in stainless steels with chromium contents greater than 16 percent.
