**How to Stop Boiler Tube  
Wastage** Caused by  
Corrosion and Erosion

This paper will discuss HVTS Cladding being used to extend the life of boiler tubes experiencing severe corrosion and erosion. The HVTS Cladding system can be rapidly installed in-situ or on new panels and elements.

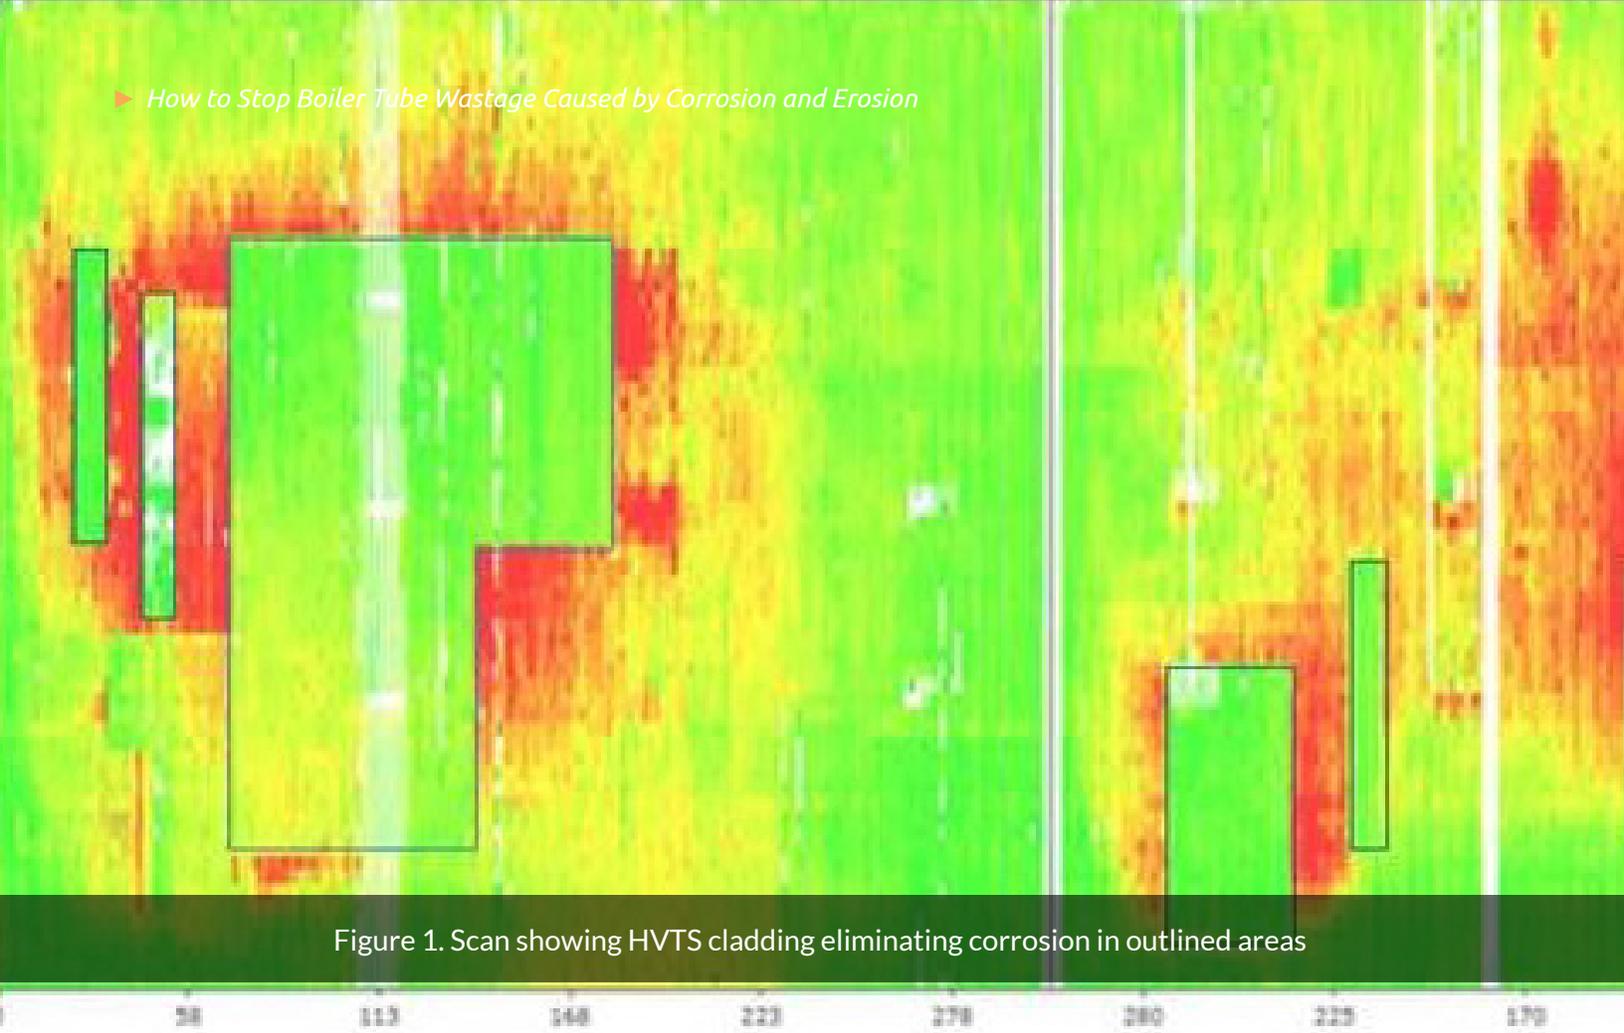
Figure 1. Scan showing HVTS cladding eliminating corrosion in outlined areas

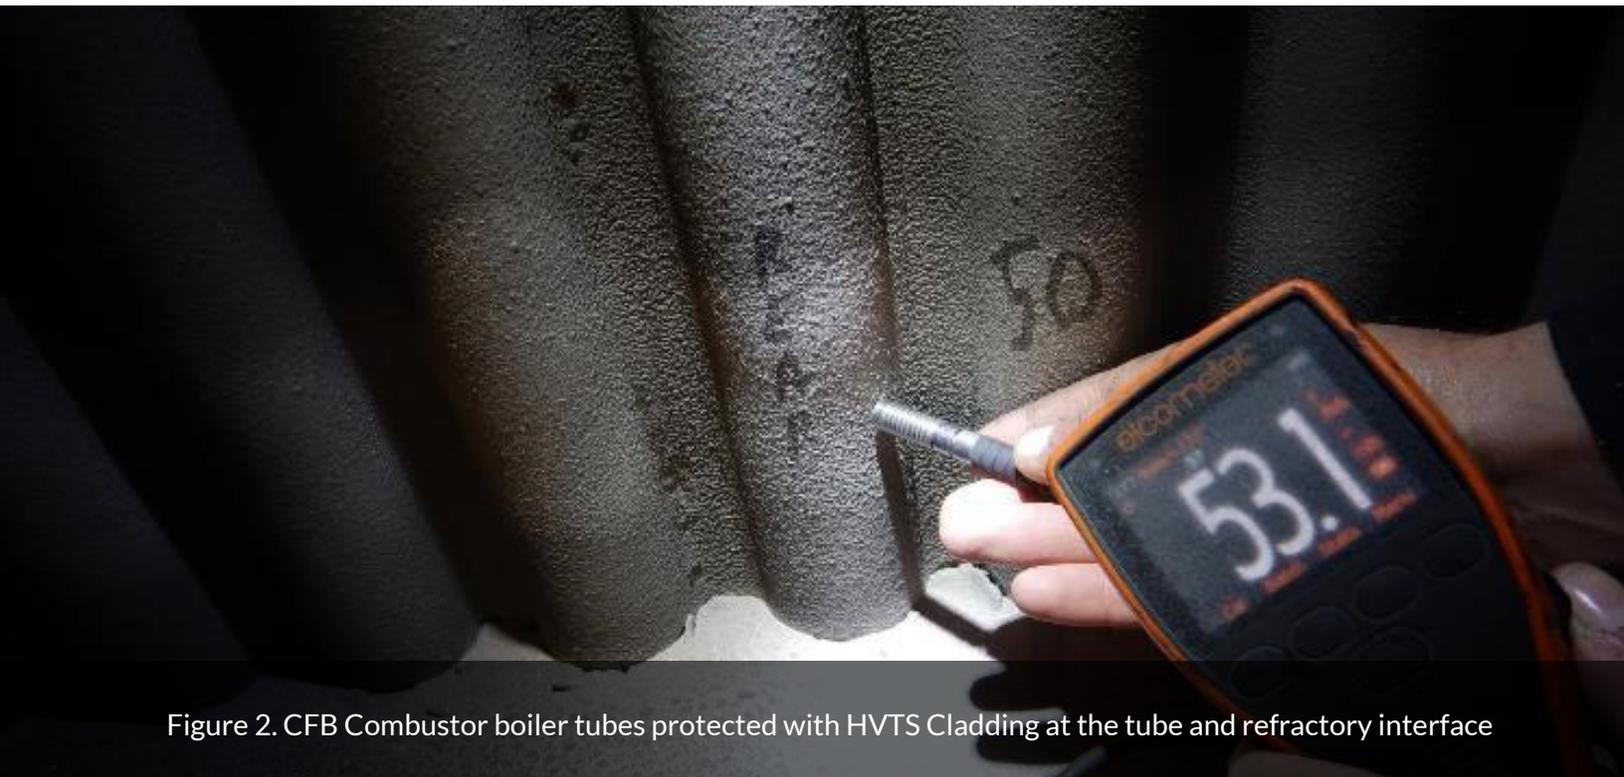
Figure 2. CFB Combustor boiler tubes protected with HVTS Cladding at the tube and refractory interface

Fly ash erosion is the second most important cause for boiler tube failure (DOE, 1998). Tube erosion in a CFB combustor can never be stopped, but HVTS Cladding is proven to slow the wastage down. HVTS Cladding is 20 times more erosion-resistant compared to carbon steel. Thousands of square feet of surface area can be rapidly installed during a short outage. The HVTS Cladding is able to be refurbished during future outages, thus it is possible to extend boiler tubes' useful life indefinitely.

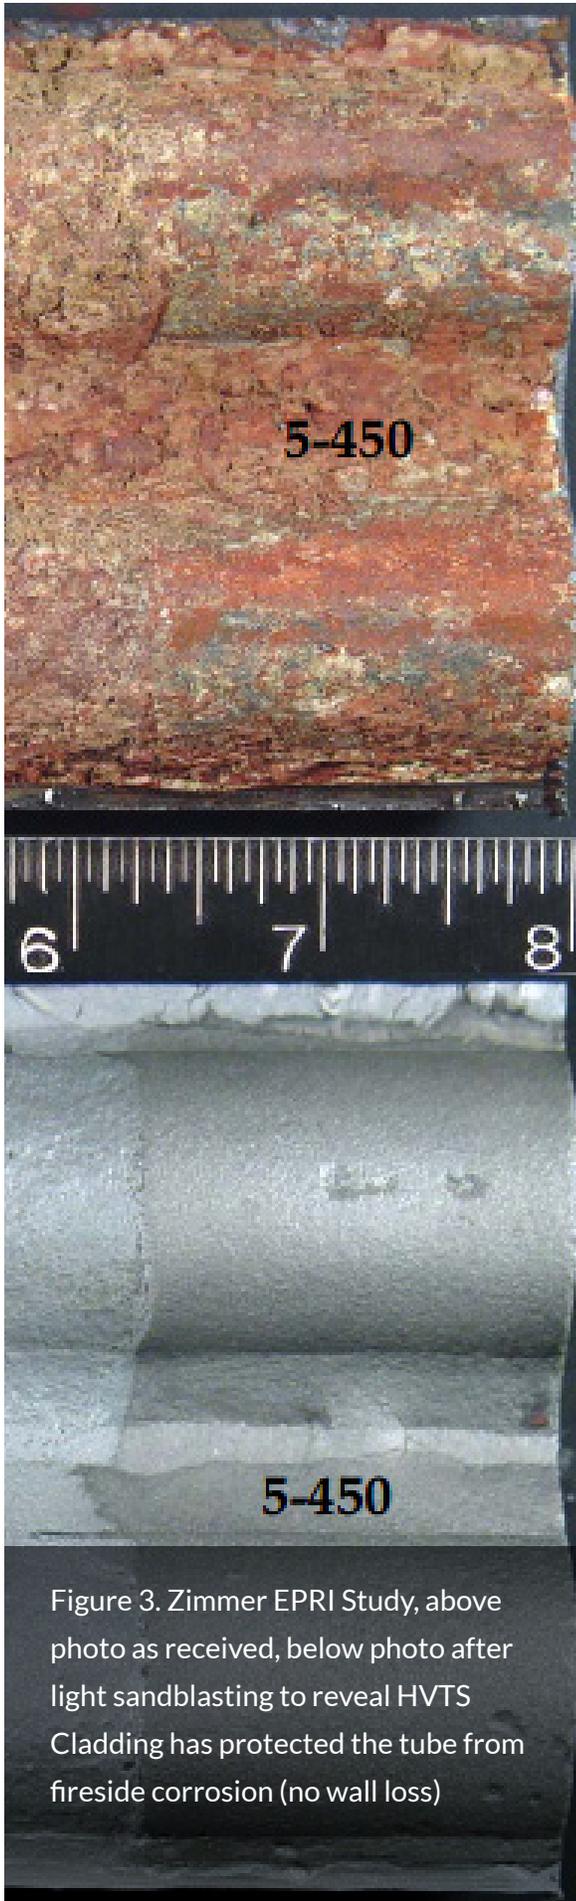
Figure 3. Zimmer EPRI Study, above photo as received, below photo after light sandblasting to reveal HVTS Cladding has protected the tube from fireside corrosion (no wall loss)

The **HVTS** Cladding was also tested by Electric Power Research Institute (EPRI), in a 1300MW high sulfur coal, supercritical boiler with Low NOx burner retrofits. Several other cladding materials were also tested, and the HVTS Cladding was the only material to fully protect the substrate from corrosion during the 39,000 hour testing period.

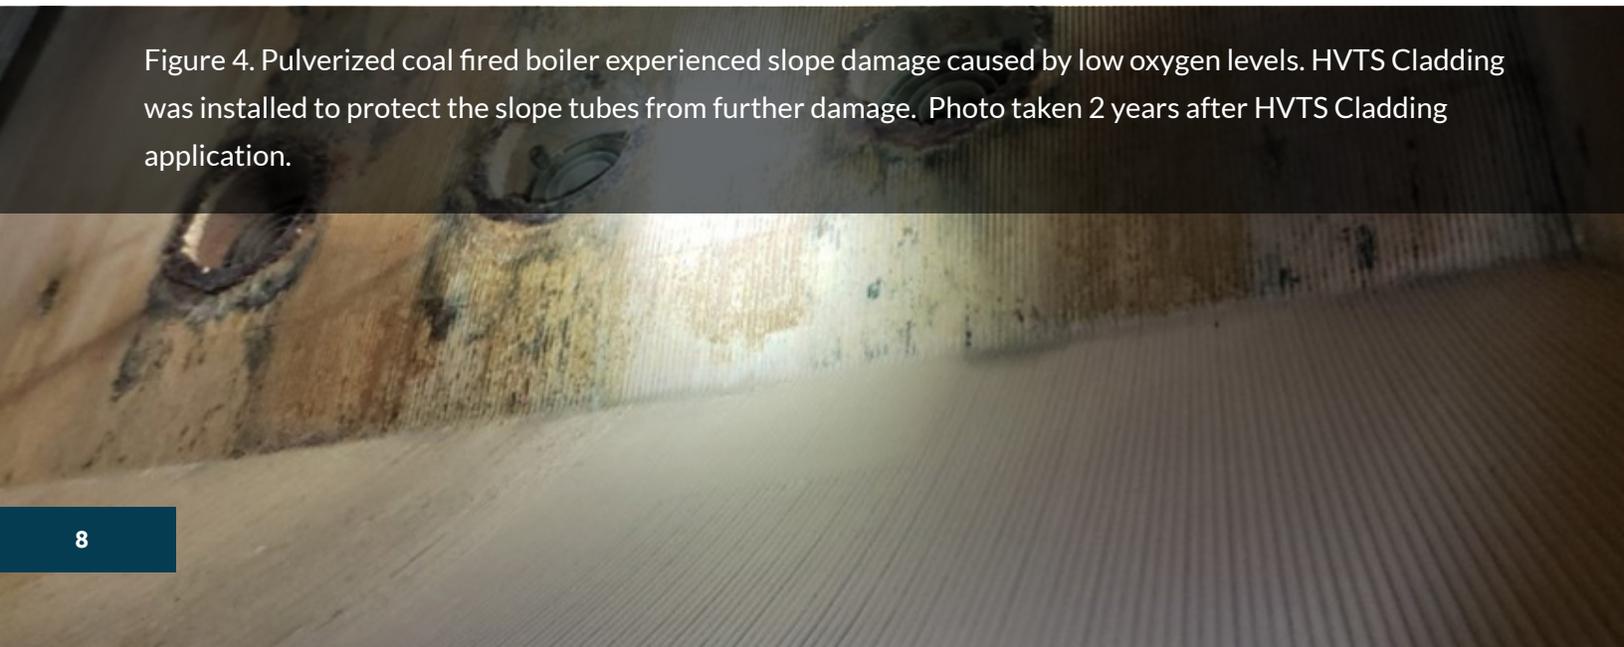
Figure 4. Pulverized coal fired boiler experienced slope damage caused by low oxygen levels. HVTS Cladding was installed to protect the slope tubes from further damage. Photo taken 2 years after HVTS Cladding application.

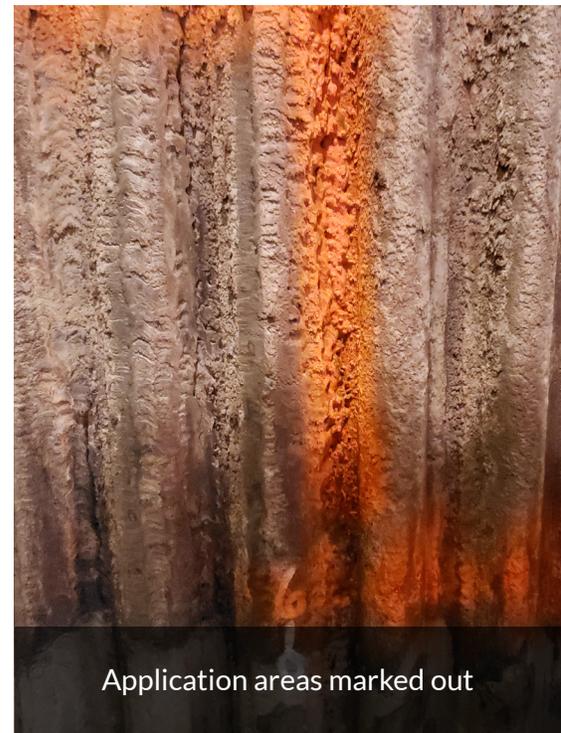
Application areas marked out

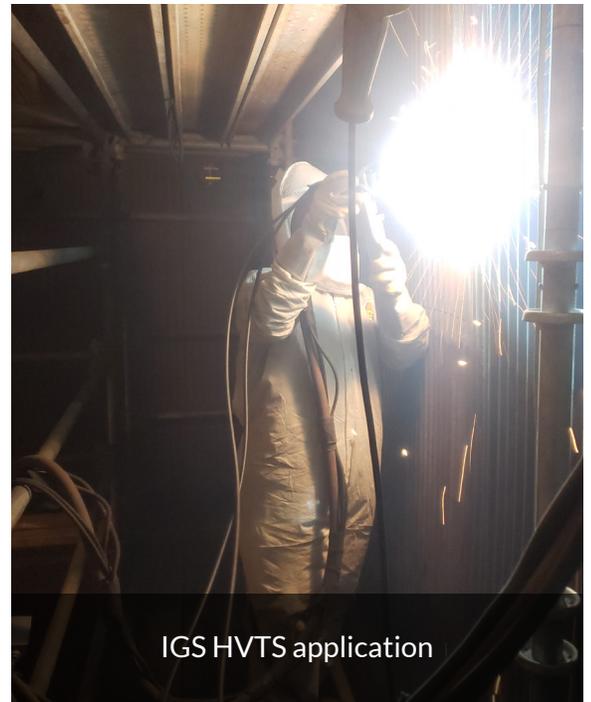
IGS HVTS application

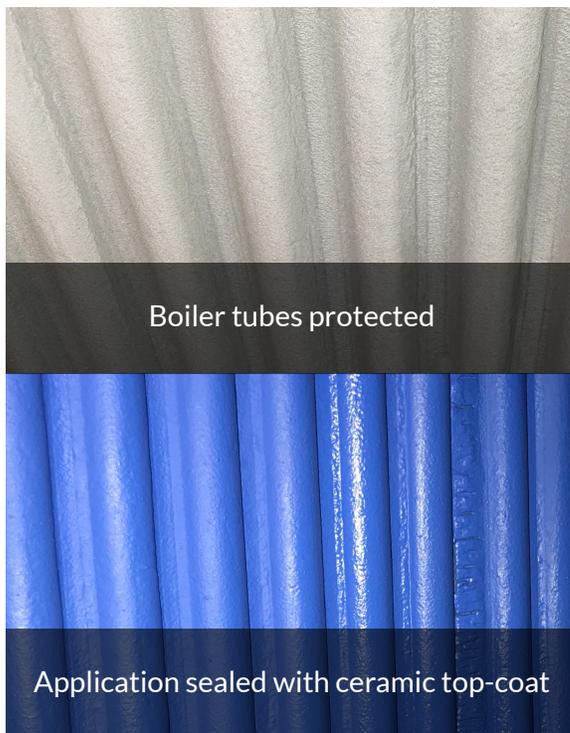
Boiler tubes protected

Application sealed with ceramic top-coat
