**How to Stop Boiler Tube
Wastage** Caused by
Corrosion and Erosion

About the White Paper

This paper will discuss HVTs Cladding being used to extend the life of boiler tubes experiencing severe corrosion and erosion. The HVTs Cladding system can be rapidly installed in-situ or on new panels and elements.

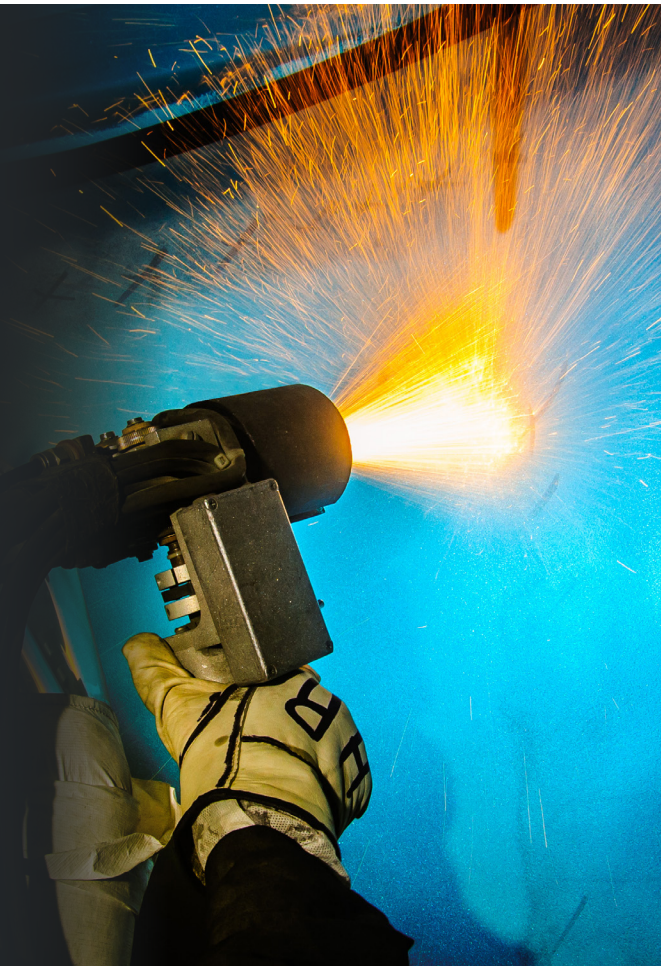
Figure 1. 1300 MW Supercritical boiler tubes suffer 40 MPY wastage caused by reducing atmosphere fireside corrosion

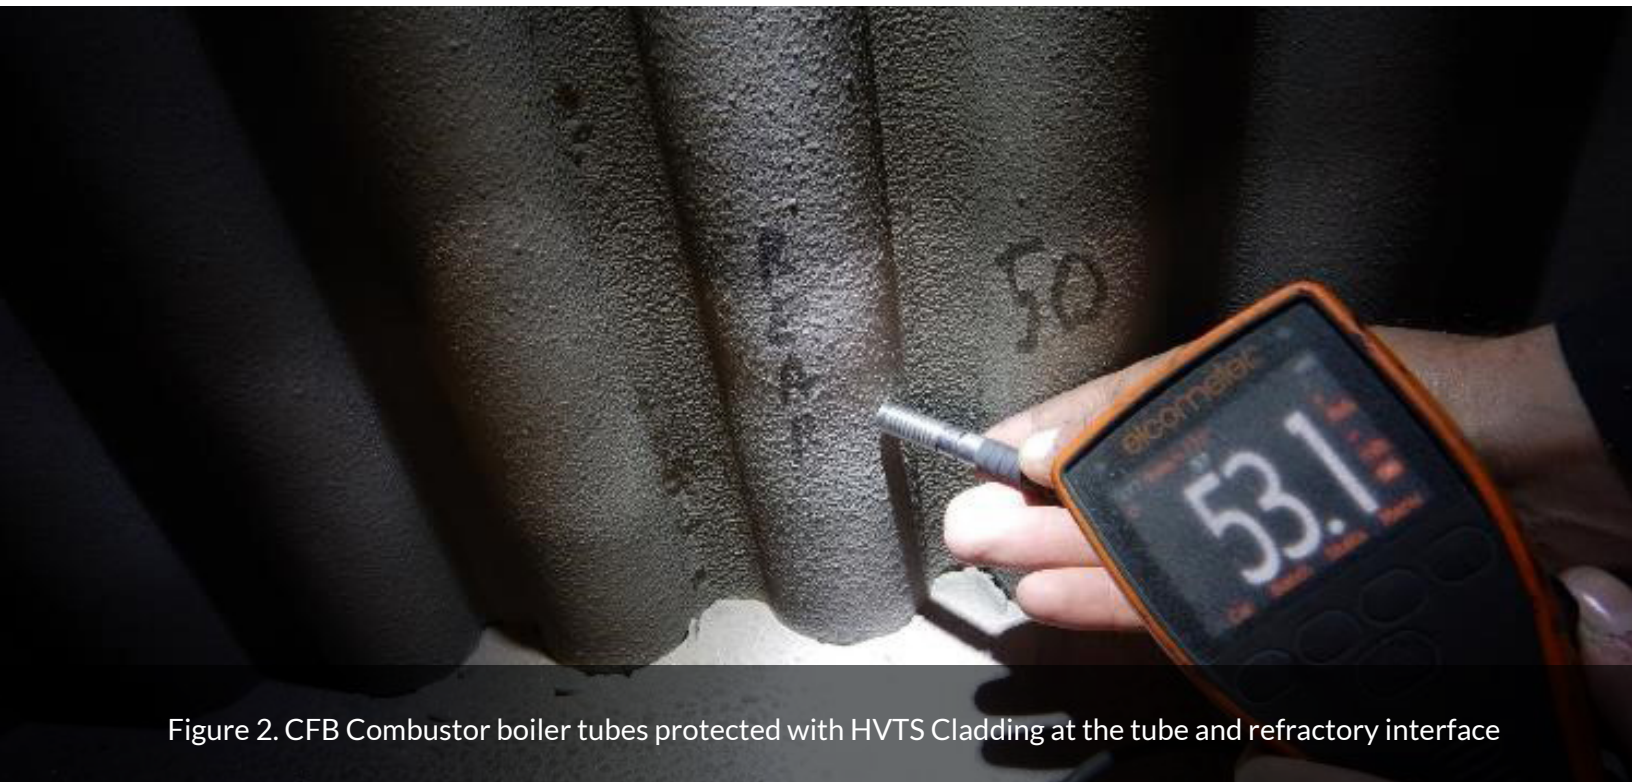
Figure 2. CFB Combustor boiler tubes protected with HVTS Cladding at the tube and refractory interface

Fly ash erosion is the second most important cause for boiler tube failure (DOE, 1998). Tube erosion in a CFB combustor can never be stopped, but HVTS Cladding is proven to slow the wastage down. HVTS Cladding is 20 times more erosion-resistant compared to carbon steel. Thousands of square feet of surface area can be rapidly installed during a short outage. The HVTS Cladding is able to be refurbished during future outages, thus it is possible to extend boiler tubes' useful life indefinitely.

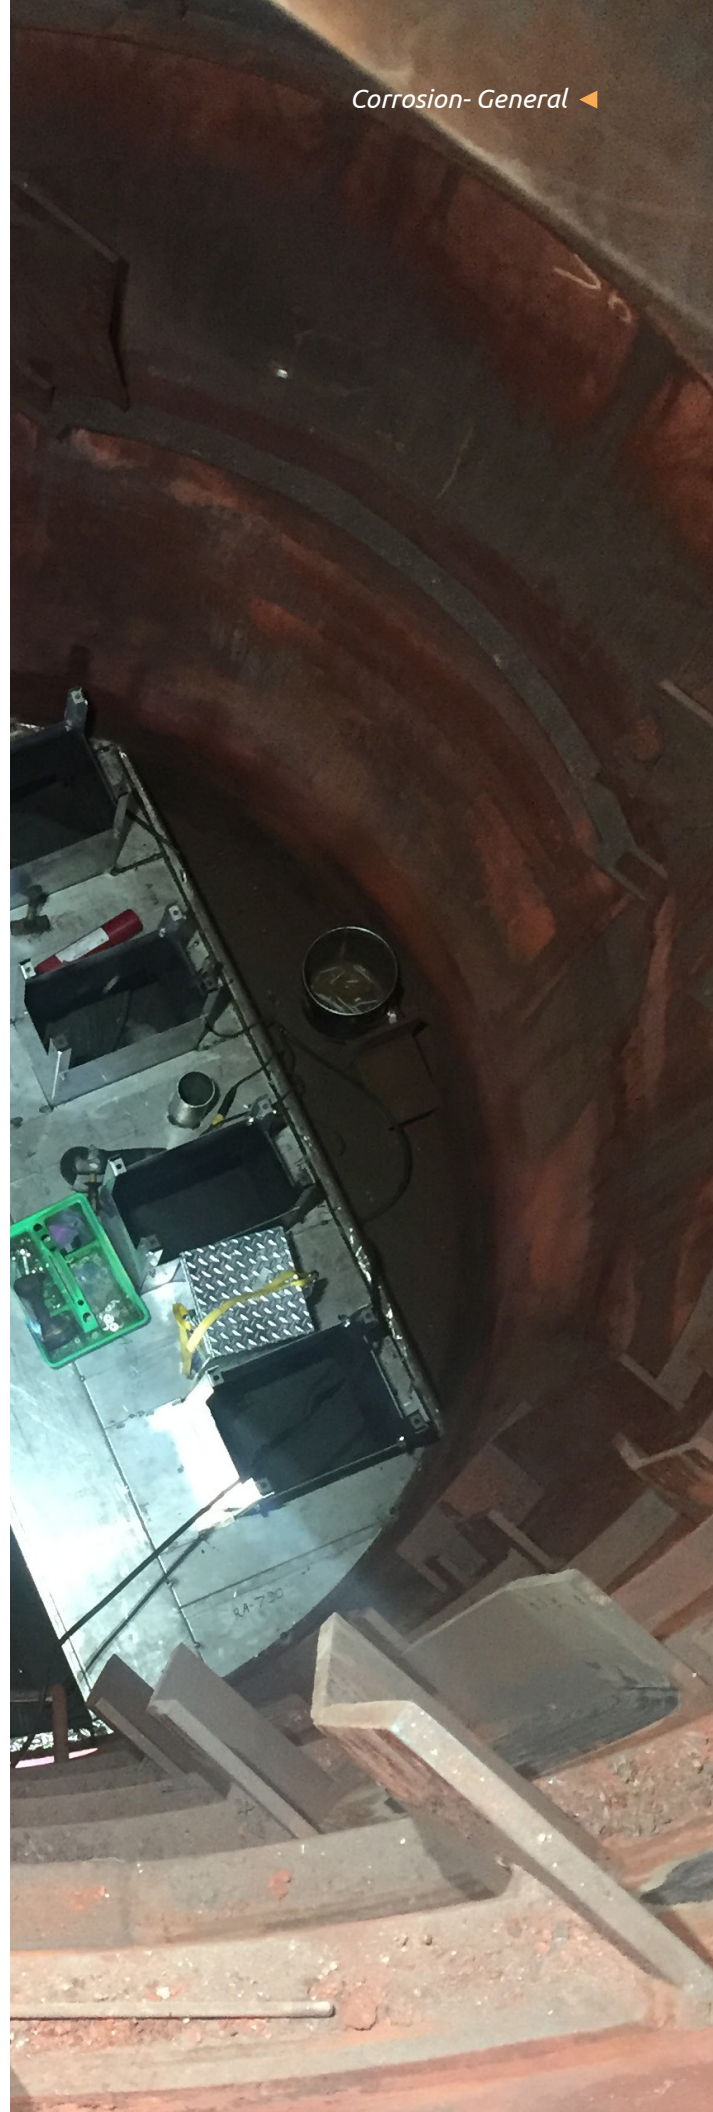
Figure 4. Pulverized coal fired boiler experienced slope damage caused by low oxygen levels. HVTS Cladding was installed to protect the slope tubes from further damage. Photo taken 2 years after HVTS Cladding application.

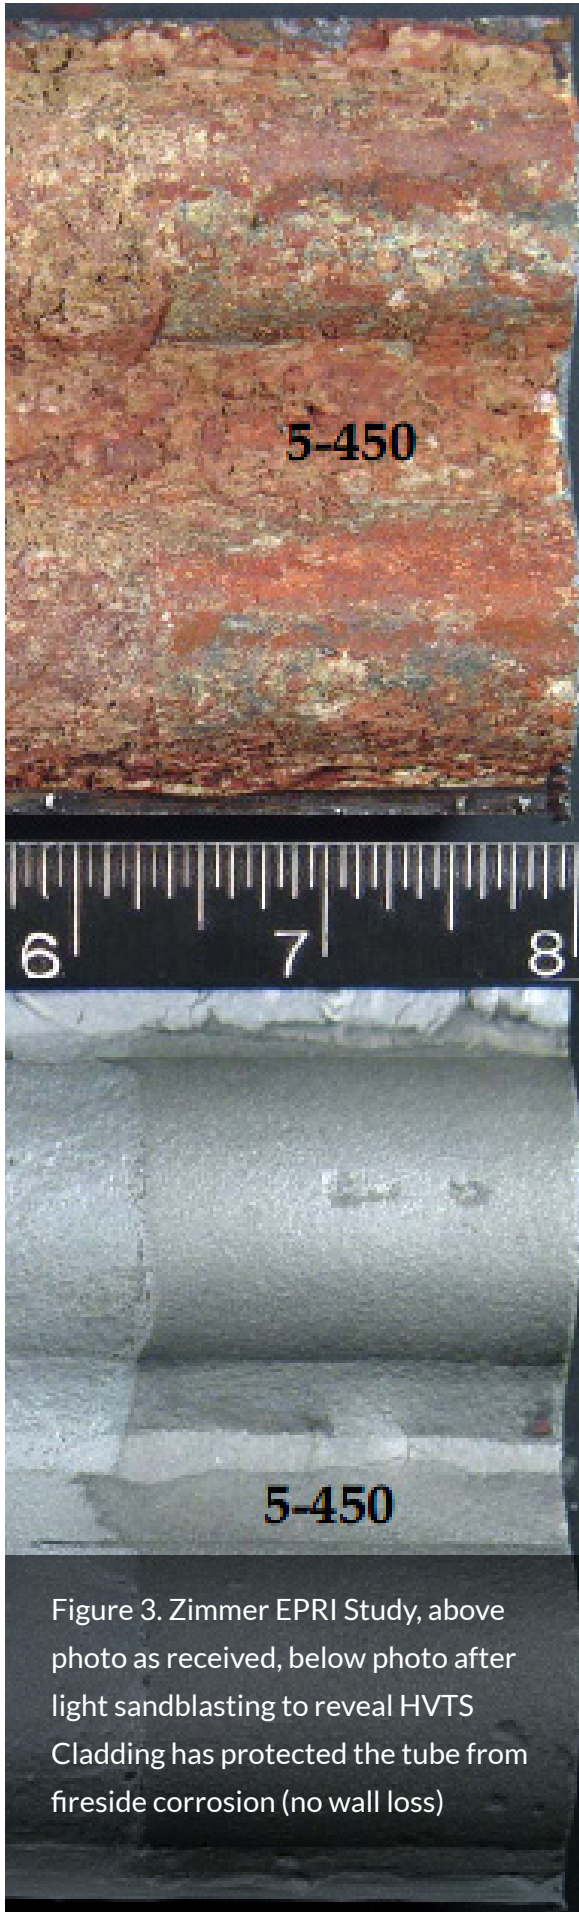
Figure 3. Zimmer EPRI Study, above photo as received, below photo after light sandblasting to reveal HVTS Cladding has protected the tube from fireside corrosion (no wall loss)

The **HVTS** Cladding was also tested by Electric Power Research Institute (EPRI), in a 1300MW high sulfur coal, supercritical boiler with Low NOx burner retrofits. Several other cladding materials were also tested, and the HVTS Cladding was the only material to fully protect the substrate from corrosion during the 39,000 hour testing period.

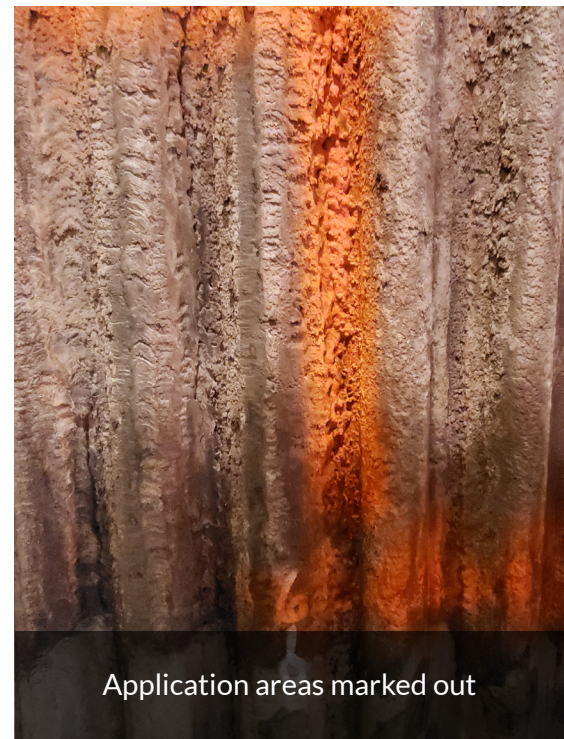
Application areas marked out

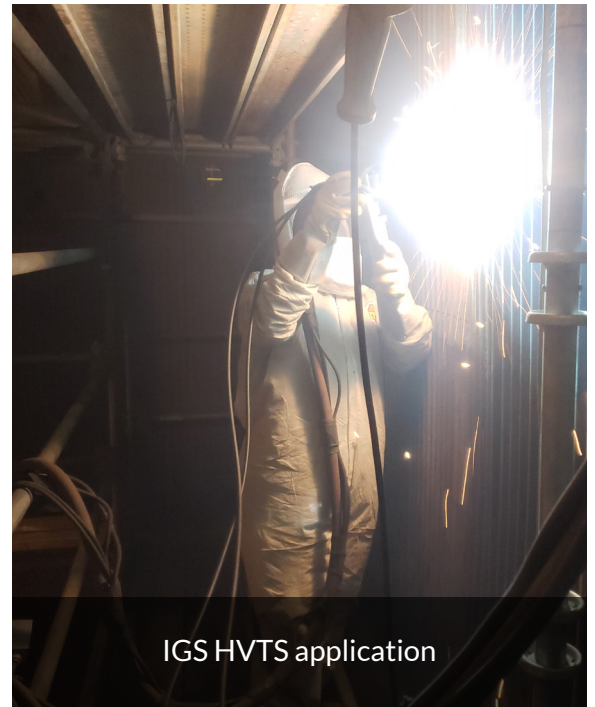
IGS HVTS application

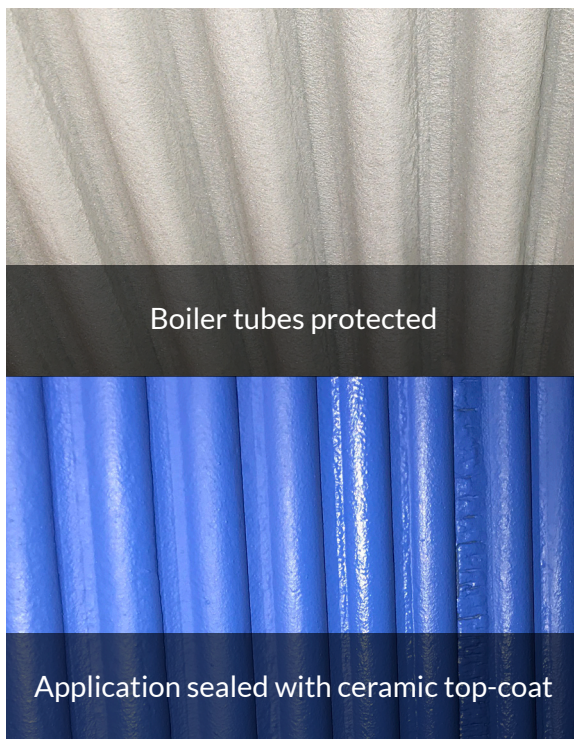
Boiler tubes protected

Application sealed with ceramic top-coat

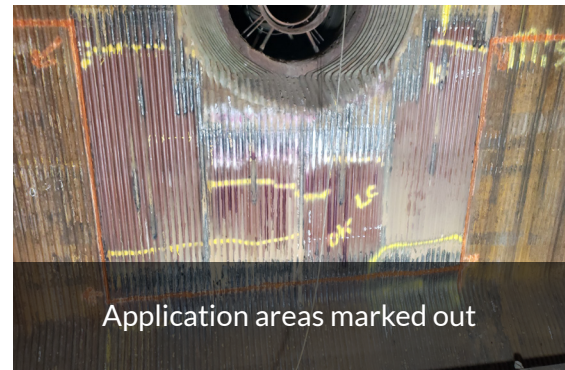
Application areas marked out

The unit was in a scheduled outage in October 2019, at which time the fireside of the tubes in the boiler were inspected by robotic UT. Wastage was discovered on both sidewalls above the existing field applied overlay, rear wall slope and burners, and front wall slope and burners. The type of damage is typical for opposed wall fired pulverized coal boilers operating in a reducing atmosphere with low NOx burners.

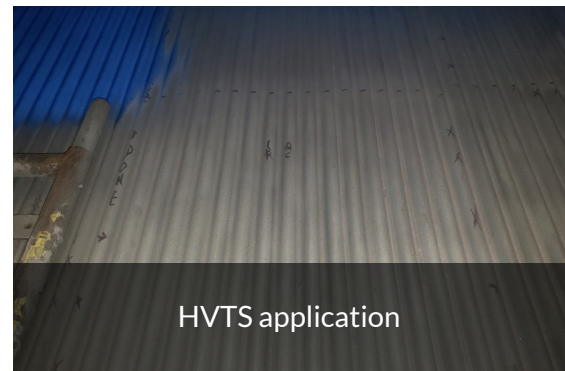
HVTS application

IGS was contracted to install 5450 EPRI Proven HVTS Alloy Cladding over the damage zones. IGS offered a rapid response and addressed the areas during the week of November 4, 2019. The IGS solution is a rather fast application - a total of 2,000 square foot of boiler tubing was protected with HVTS in 5 short days.

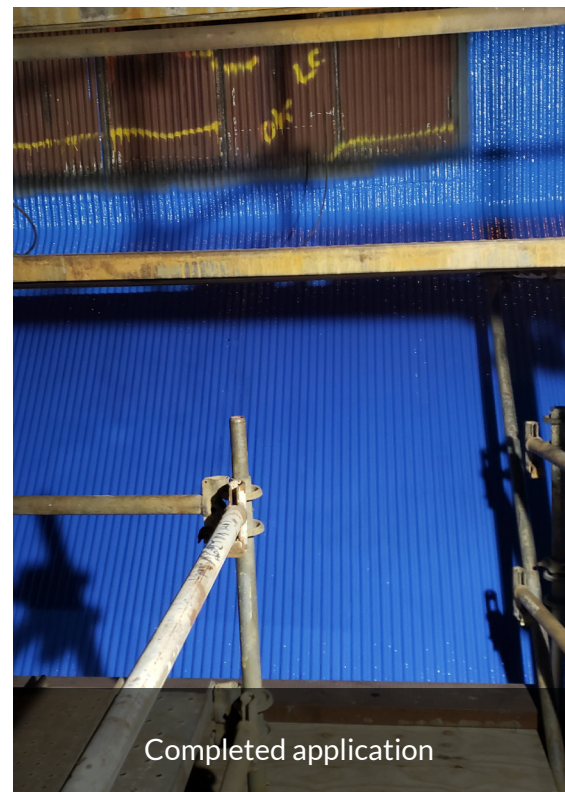
Completed application
